A MORE RELIABLE PUMPS REDUNDANCY DESIGN

Abstract: This paper describes the benefits and practicalities of a more reliable repeater pump redundancy design by utilizing four pump lasers backup within a two fiber-pairs system. The test result shows that this sort of redundancy provides submarine systems more reliability and thus sturdier to tolerance of up to three pump lasers failure, which ultimately can be detected by COTDR equipment.

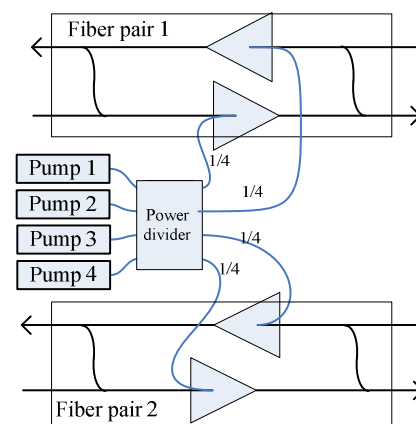
Figure 1: Four pumps in a two fiber pairs system

Figure 1 illustrates the architecture of four pump lasers backup for two fiber pairs. The output power of each pump laser is equally divided into four parts by power divider, and evenly distributed over the four EDFAs. By adjusting the operating current, the output power of any pump laser could be same to each other. In other words, if one pump laser fails, each EDFA

will therefore only lose a quarter of the pump power.

This pump architecture design can easily be extended to more fiber pairs system, the power divider should be designed to keep the energy of every EDFA equally comes from the four pump lasers, and each laser pump providing the same pump power.

The repeaters in figure 2 have 4 pump lasers backup which is illustrated in figure 1, and EDFAs are working at a deep gain compression state, which is illustrated in figure 3. The gain compression characteristic mean that the repeater can self-compensate the output power and gain when its input power drops off; in which case, the optical power level along a chain of repeaters could automatically self-correct.

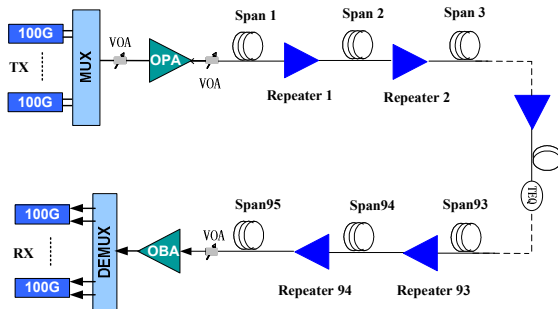
Figure 2: The transmission path during pump failure tests [Note 1]

The experimental setup is illustrated in figure 2. The system capacity is 80 channels 100Gbit/s with PDM-QPSK modulation. The transmission line consists of more than 6100 km Corning EX2000 fiber, 94 repeaters, several TEQs and SEQs.

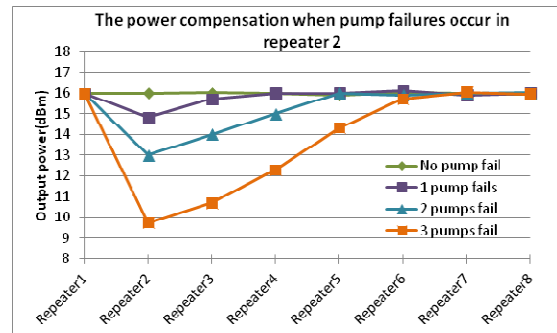
Figure 4: The power compensation when pump failures occur in repeater 2

Figure 4 illustrates the optical power self-adjusting from repeaters 1 to 8 when a pump failure occurs in repeater 2. If the pump lasers fails in repeater 2, the output power of repeater 2 will decrease, but the optical power can self-compensate from repeaters 3 to 6, and return to the normal level after repeater 6 even though three pumps failure.

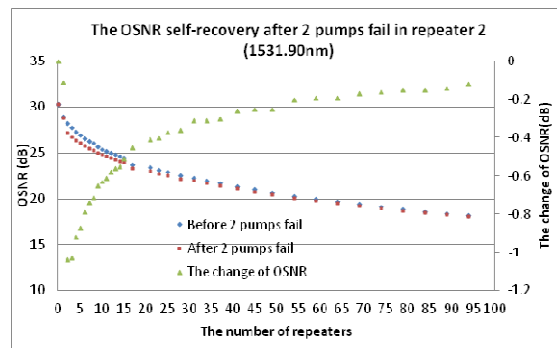
Figure 5: The OSNR self-recovery when 2 pump lasers fail in repeater 2

Similar to the optical power self-adjustment option, the OSNR can also self-recover along a chain of repeaters when pump failures occur. Figure 5 illustrates the OSNR of 1531.90nm along the transmission line before and after 2 pump lasers failed in repeater 2. The maximum decrease of OSNR appears at repeater 2, the OSNR then begins to self-recover along the transmission line, and the degradation is less than 0.2dB at the last repeater.

Therefore, according to figure 5, the worst case would be if the pump failure happens in the last repeater, because there is only one OBA to compensate optical power. So we measure the OSNR of all channels at RX side when one, two, and three pump lasers failed in repeater 94, this is illustrated in figures 8 and 9. It should be noted that the degradation of RX OSNR is still less than 0.7dB when 3 laser pumps failed due to the strong compensation by OBA.

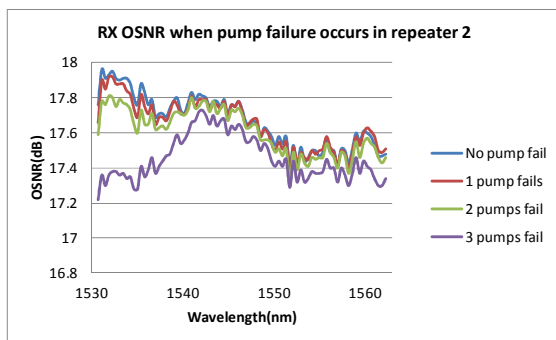
Figure 6: RX OSNR when pump lasers fail in repeater 2

The OSNR of all channels at the RX side is measured when one, two, and three pump lasers failed in repeater 2, which is illustrated in figures 6 and 7. The test results show that the degradation of RX OSNR is less than 0.2dB when 1 or 2 pumps failure, and less than 0.7dB when 3 laser pumps failed.

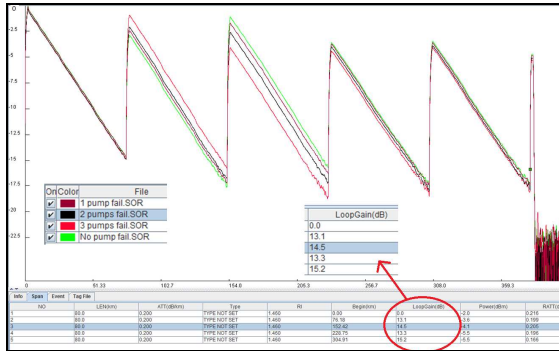
Figure 11 illustrates the COTDR curves when pump failures happen in repeater 2; with the baseline (no pump failure) being the green curve. In this instance, the

COTDR equipment could work out the gain of repeaters, by differentiating with baseline, it also can determine the changes of the gain.

Figure 11: The COTDR curves (Test conditions: Pulse Width :20us, Pulse peak power: -4dBm, Average times: 100,000)

Theoretically, the gain of repeater with 4 pump redundancy will decrease 1.25dB when one laser pump fails, 3dB when two laser pumps fail and 6dB when three laser pumps fail. The accuracy of the COTDR equipment is +/-0.5dB, therefore, when one, two or three pumps fail, the change in the gain tested by the COTDR will be -1.25+/-0.5dB, -3.0+/-0.5dB and -6.0+/-0.5dB respectively.
